Pentium® III Xeon™ Processor Specification Update

Release Date: September 1999

Order Number: 244460-006

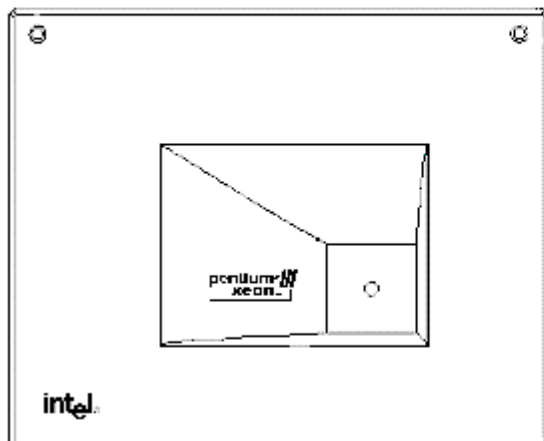
Pentium® III Xeon™ and Boxed Pentium® III Xeon™ Processor Markings

Production Dynamic Mark Example:

500/512/100/2.0V S1
 FFFFFFFF-NNNN {country}
 i®©'98 SSSSS

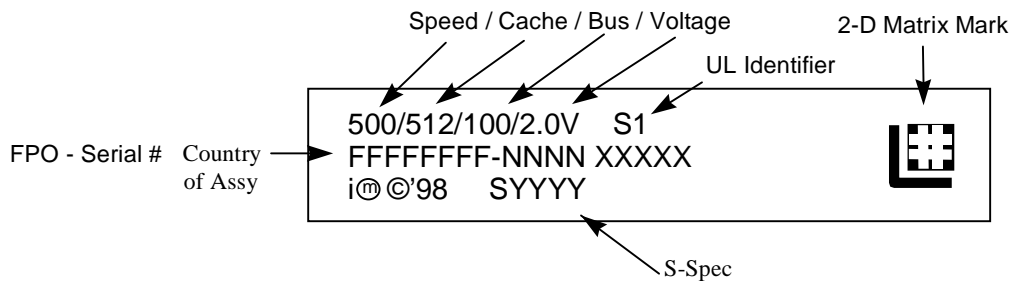
FFFFFFF-NNNN

Dynamic Mark Area
